**Flood Control Project Maintenance
Levee Inspections**
LMA District Cover Sheet
Spring 2019 Levee Inspection Results

Reclamation District No. 2063 Crows Landing

Spring 2019 Levee Inspection Results

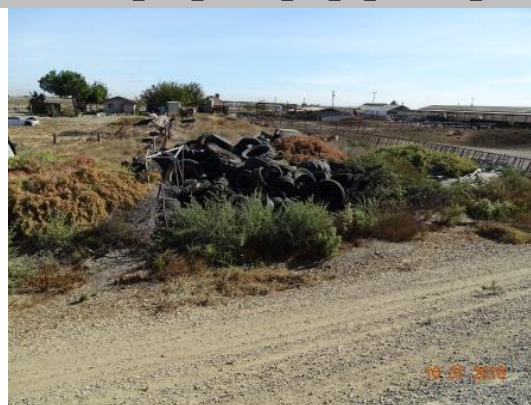
Photo 1 of 1 : SP_2019_RD2063_112_44_20190307_00009.jpg

LM Start	3.57	Rating **	A/W	Issue No.	44
LM End	3.57	Issue Type +	En	Location *	LS
Category	Earthen Levee			GPS Latitude/Longitude	
				Start	End
Item	Encroachments			37.437761 °	37.437761 °
				-121.018535 °	-121.018535 °
DWR ID	DWR_RD2063_01_f_2018_44				
Comment Code					
DE : Debris					
Inspector Comment					
Garbage pushed back away from toe. Monitor to ensure it does not encroach back upon 10 ft buffer from toe.

View of tires and garbage left at the levee toe. (Fall 2018)

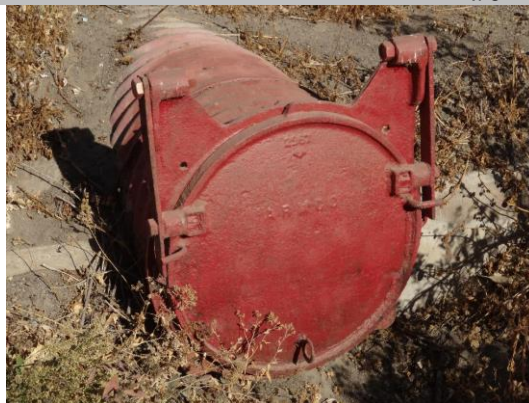
Photo 1 of 3 : UCIP_SP_2019_24485_43667.jpg

WS view: pipe, flap gate, and concrete saddle on levee slope

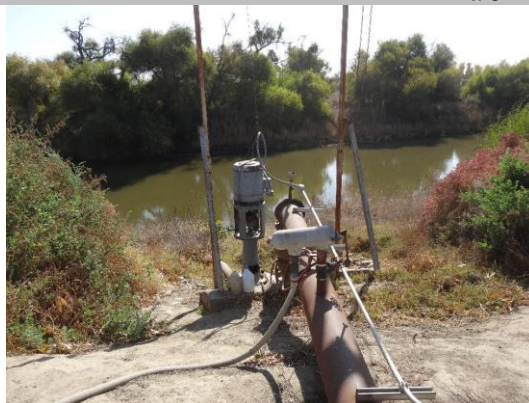
Photo 2 of 3 : UCIP_SP_2019_25028_45124.jpg

WS view: pump, pipe and other appurtenances on levee toe.

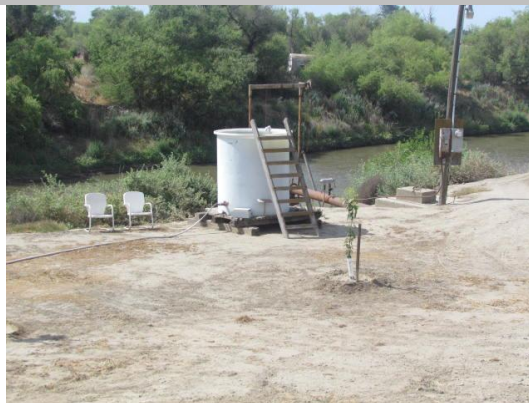
Photo 1 of 3 : SP_2019_RD2063_112_31_20190307_00004.jpg

LM Start	4.60	Rating **	M	Issue No.	31
LM End	4.60	Issue Type +	En	Location *	WS
Category	Earthen Levee			GPS Latitude/Longitude	
				Start	End
Item	Encroachments			37.429638 °	37.429638 °
				-121.005348 °	-121.005348 °
DWR ID	DWR_RD2063_01_s_2012_31				
Comment Code					
CR : Crops					
Inspector Comment					
Landowner planted grape vines and fruit trees and water tank on waterside berm without a permit from the CVFPB.

Looking west at water tank on waterward berm.

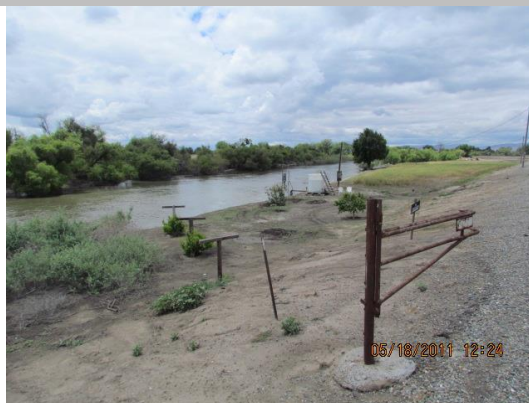
Photo 2 of 3 : SP_2019_RD2063_112_31_20190307_00005.jpg

Looking south at grapevines and fruit trees on waterside berm.

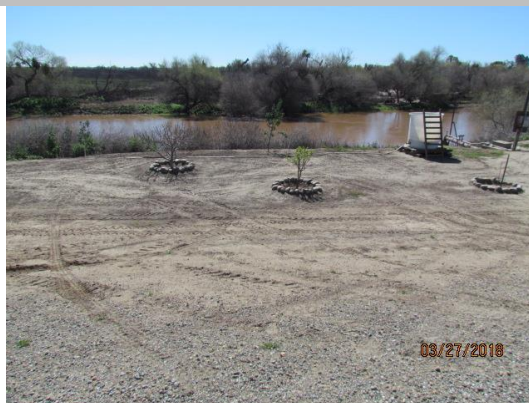
Photo 3 of 3 : SP_2019_RD2063_112_31_20190307_00006.jpg

Looking west at trees with retaining wall around trees. (Spring 2018)

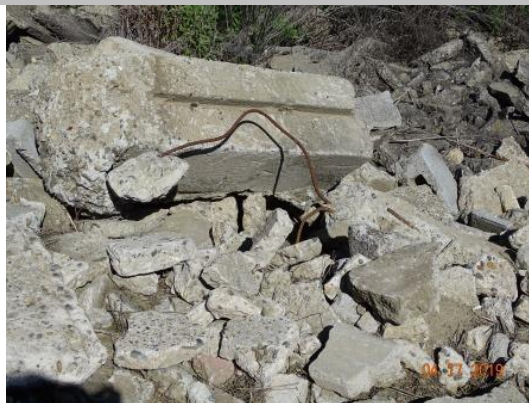
Photo 1 of 1 : SP_2019_RD2063_112_40_20190501_00111.jpg

LM Start	6.01	Rating **	M	Issue No.	40
LM End	6.01	Issue Type +	Ma	Location *	WS
Category	Earthen Levee			GPS Latitude/Longitude	
				Start	End
Item	Riprap Revetments			37.415710 °	37.415710 °
				-120.998530 °	-120.998530 °
DWR ID	DWR_RD2063_01_s_2019_40				
Comment Code					
Inspector Comment					
Concrete revetment with rebar should be removed.

Representative view of concrete rip rap used at this location. (Spring 2019)

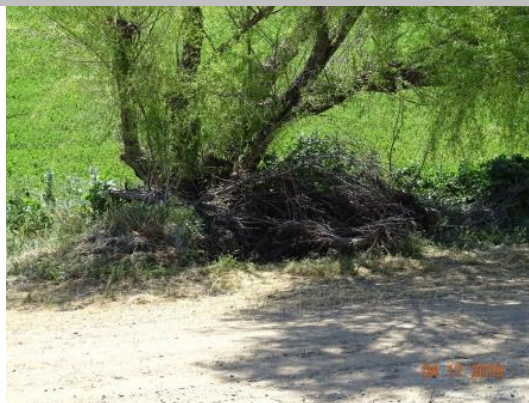
Photo 1 of 2 : SP_2019_RD2063_112_49_20190501_00112.jpg

LM Start	6.20	Rating **	M	Issue No.	49
LM End	6.20	Issue Type +	En	Location *	LS
Category	Earthen Levee			GPS Latitude/Longitude	
				Start	End
Item	Encroachments			37.414171 °	37.414171 °
				-121.001353 °	-121.001353 °
DWR ID	DWR_RD2063_01_s_2019_49				
Comment Code					
PR : Prunings					
Inspector Comment

View of prunings looking down landside slope. (Spring 2019)

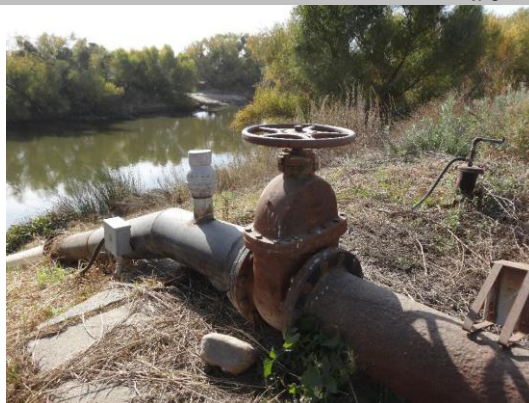
Photo 1 of 3 : UCIP_SP_2019_24628_43938.jpg

WS view: steel pipe, gate valve, air vent on levee berm.

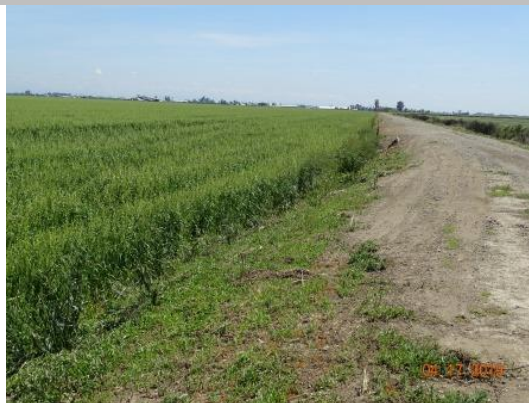
Photo 1 of 2 : SP_2019_RD2063_112_55_20190501_00114.jpg

LM Start	9.46	Rating **	U	Issue No.	55
LM End	10.41	Issue Type +	En	Location *	LS
Category	Earthen Levee			GPS Latitude/Longitude	
				Start	End
Item	Encroachments			37.390683 °	37.390503 °
				-120.959037 °	-120.941741 °
DWR ID	DWR_RD2063_01_s_2019_55				
Comment Code					
CR : Crops					
Inspector Comment					
Crops planted in landside toe right up against the slope.

View of landside slope looking upstream. (Spring 2019)

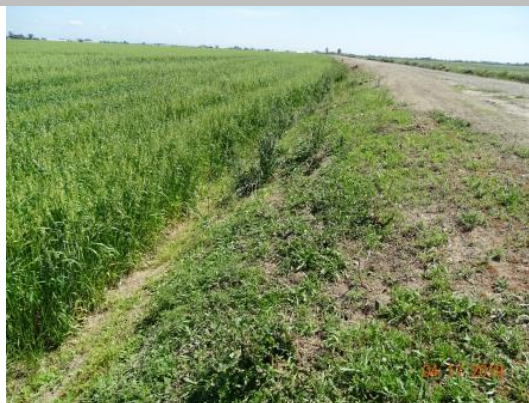
Photo 2 of 2 : SP_2019_RD2063_112_55_20190501_00115.jpg

Crops planted on landside toe up against the slope. (Spring 2019)

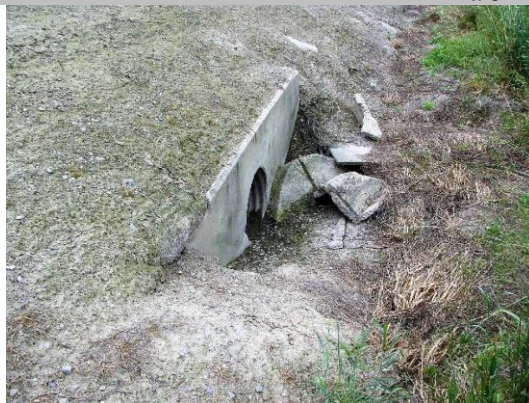
Photo 1 of 3 : UCIP_SP_2019_51825_77044.jpg

LS inlet as of 4/11/2017 levee inspection. Photo courtesy of DWR inspector Richard Willoughby.

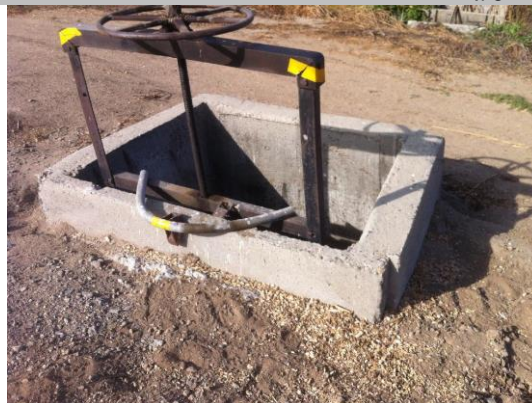
Photo 2 of 3 : UCIP_SP_2019_24644_43985.jpg

LS view: CM pipe with slide gate on inlet concrete box.
